The Road Inventory of Pond Creek National Wildlife Refuge Lockesburg, AR

Prepared By:
Federal Highway Administration
Central Federal Lands Highway Division
October, 2011

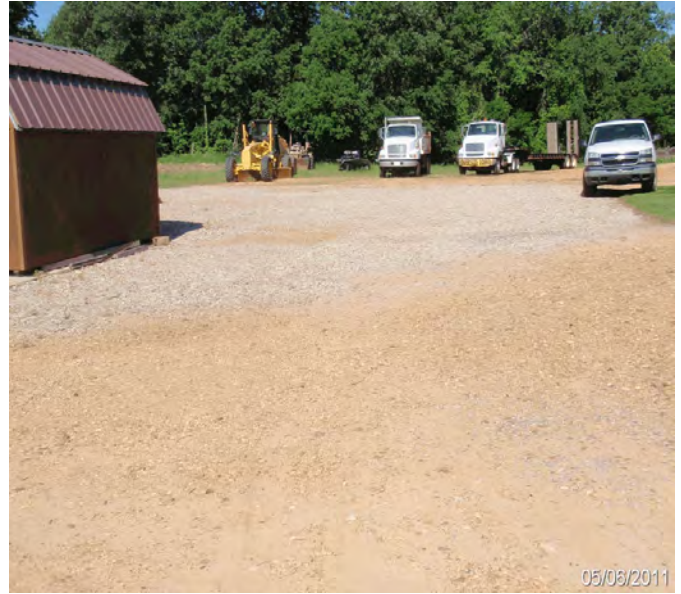
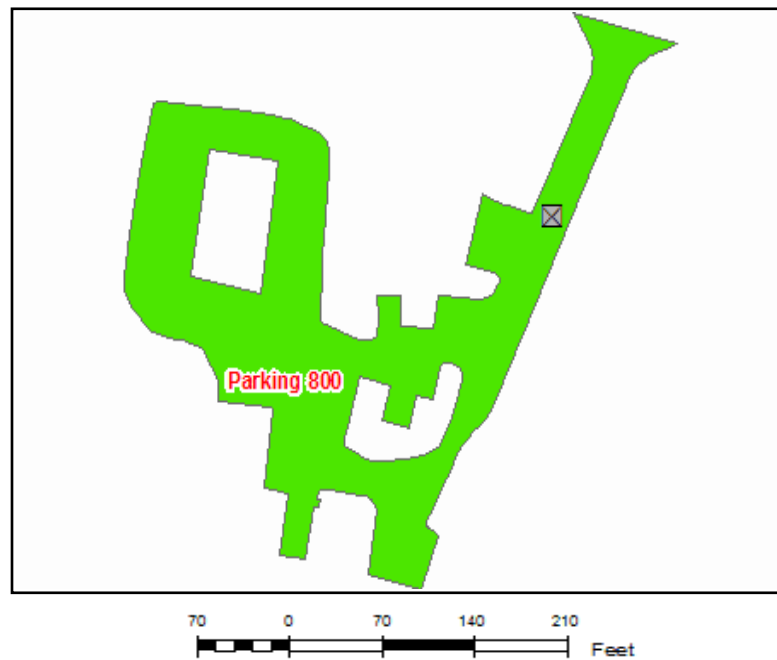
800: Shop/Headquarters Parking

Asset Number	Date Visited	Surface Type	Area (Sq Ft)	Condition	Cost to Improve
10061327	05/06/2011	Gravel	62,735	Good	8,300

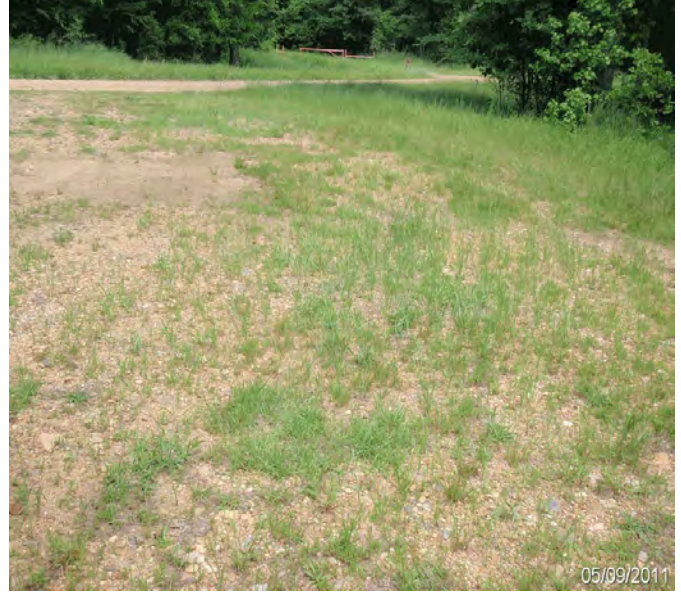
900: River Road Parking

Asset Number	Date Visited	Surface Type	Area (Sq Ft)	Condition	Cost to Improve
	05/09/2011	Gravel	7,420	Fair	1,700

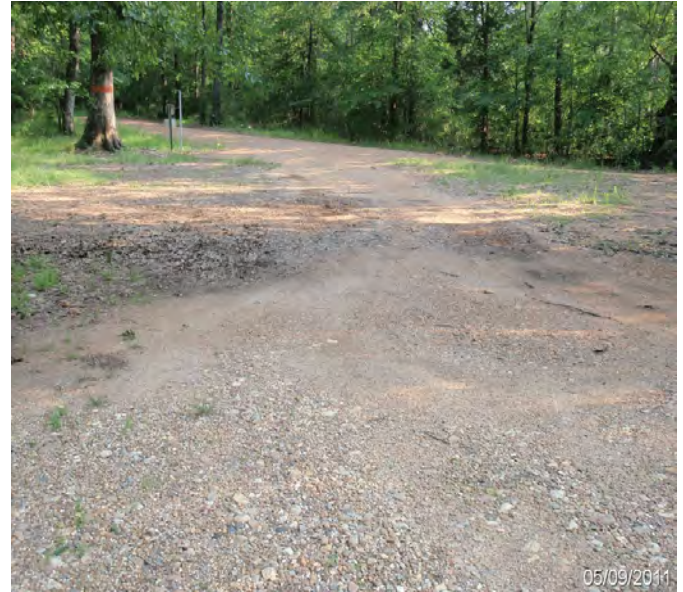
901: Red Lake Campground Parking

Asset Number	Date Visited	Surface Type	Area (Sq Ft)	Condition	Cost to Improve
	05/09/2011	Gravel	17,533	Fair	4,100

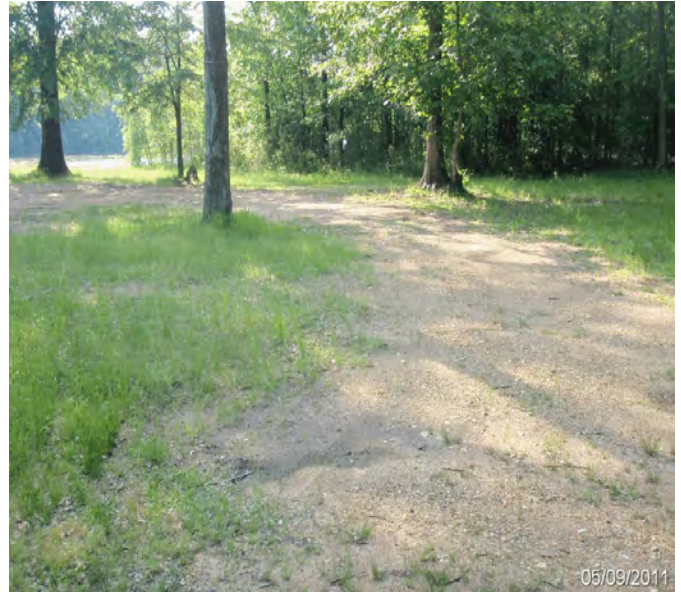
902: Gillahand Shoals Campground Parking

Asset Number	Date Visited	Surface Type	Area (Sq Ft)	Condition	Cost to Improve
	05/09/2011	Gravel	3,220	Fair	800

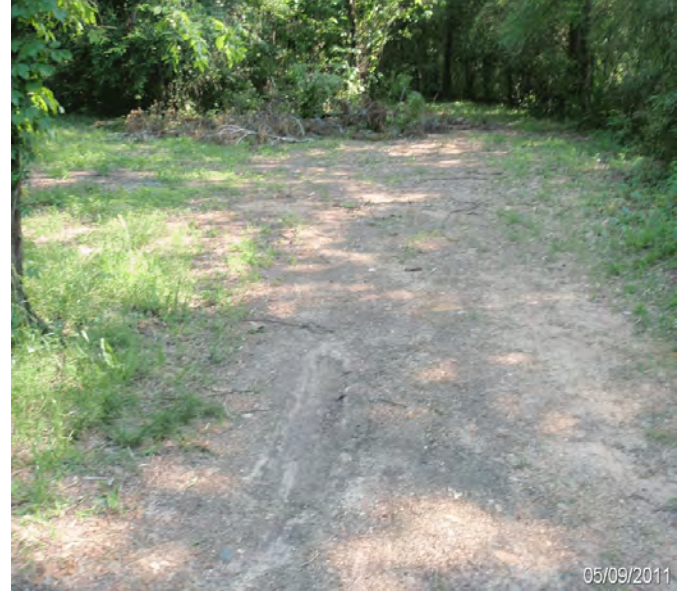
903: South Yellow Bank Campground Parking

Asset Number	Date Visited	Surface Type	Area (Sq Ft)	Condition	Cost to Improve
	05/10/2011	Gravel	3,408	Fair	800

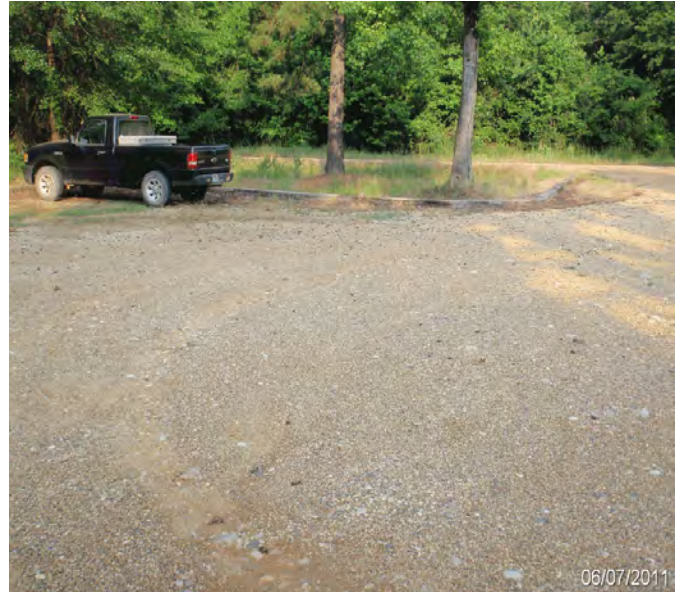
906: Nobels Mound Road Kiosk Parking

Asset Number	Date Visited	Surface Type	Area (Sq Ft)	Condition	Cost to Improve
	05/10/2011	Gravel	7,291	Good	1,000

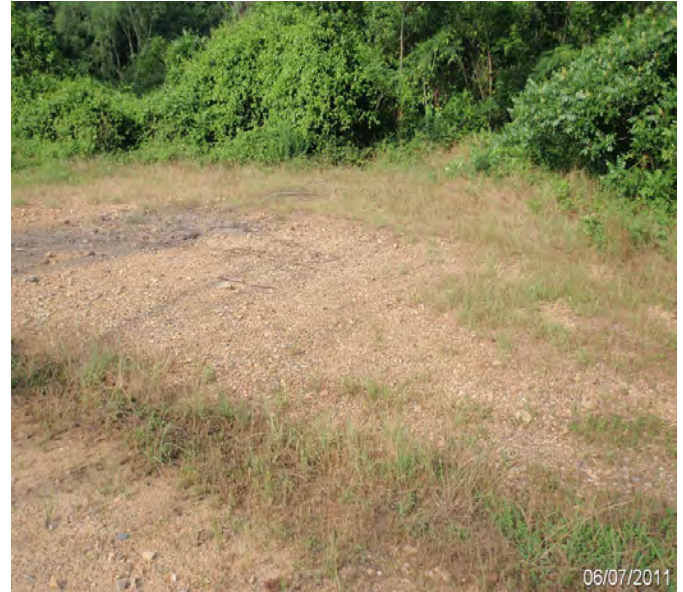
908: Nobels Mound Pond Parking

Asset Number	Date Visited	Surface Type	Area (Sq Ft)	Condition	Cost to Improve
	05/10/2011	Gravel	2,089	Fair	500

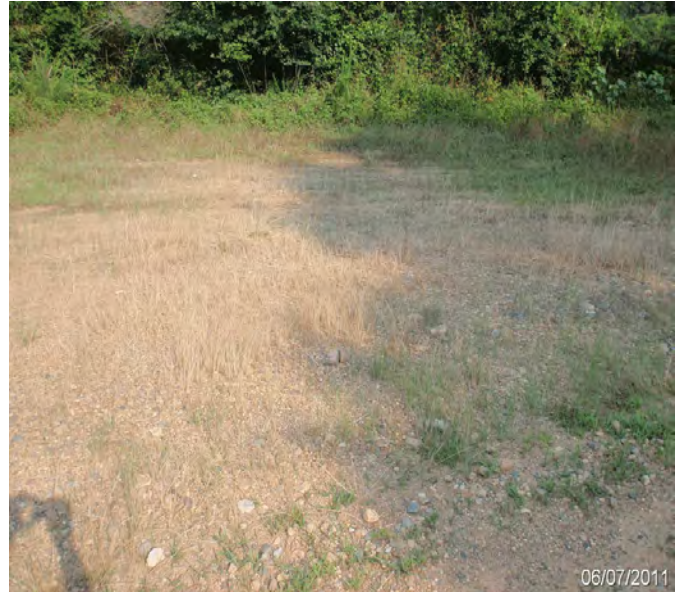
909: Nobels Mound Parking

Asset Number	Date Visited	Surface Type	Area (Sq Ft)	Condition	Cost to Improve
	06/07/2011	Gravel	1,626	Fair	400

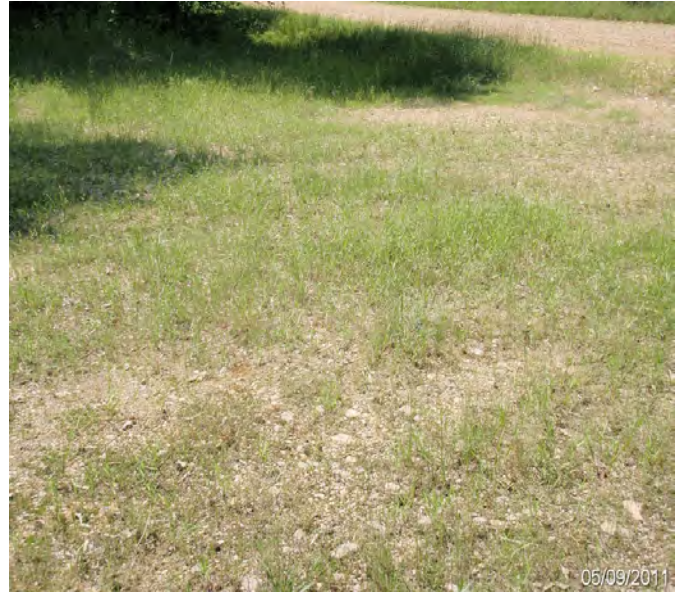
911: Bridge Creek/Tram ATV Parking

Asset Number	Date Visited	Surface Type	Area (Sq Ft)	Condition	Cost to Improve
	05/09/2011	Gravel	2,564	Fair	600

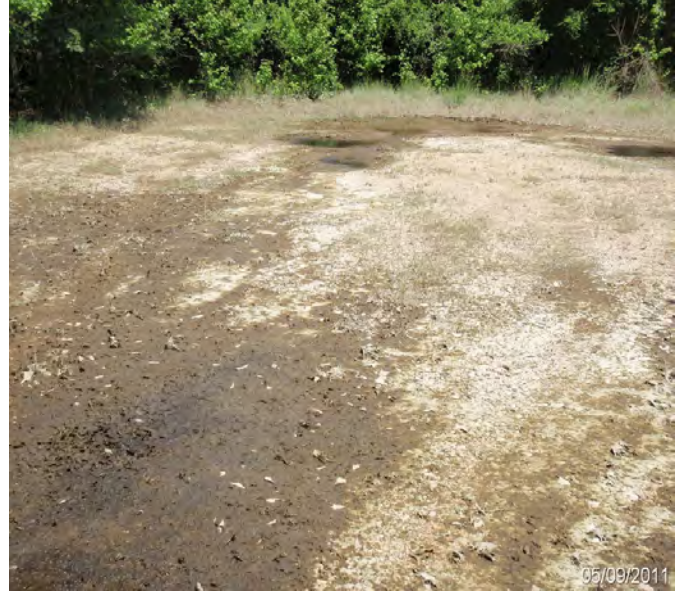
912: Salt Lick Spur Parking

Asset Number	Date Visited	Surface Type	Area (Sq Ft)	Condition	Cost to Improve
	05/09/2011	Gravel	2,586	Poor	2,500

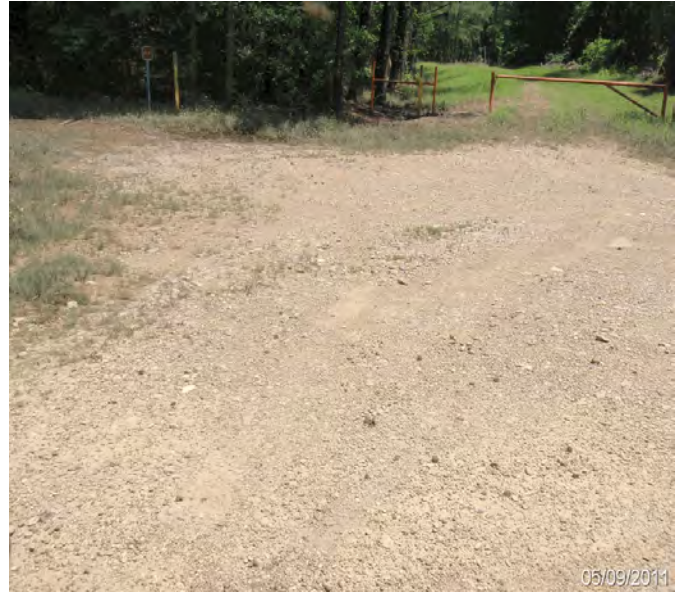
914: Salt Lick/Pipeline Parking

Asset Number	Date Visited	Surface Type	Area (Sq Ft)	Condition	Cost to Improve
	05/09/2011	Gravel	3,161	Fair	700

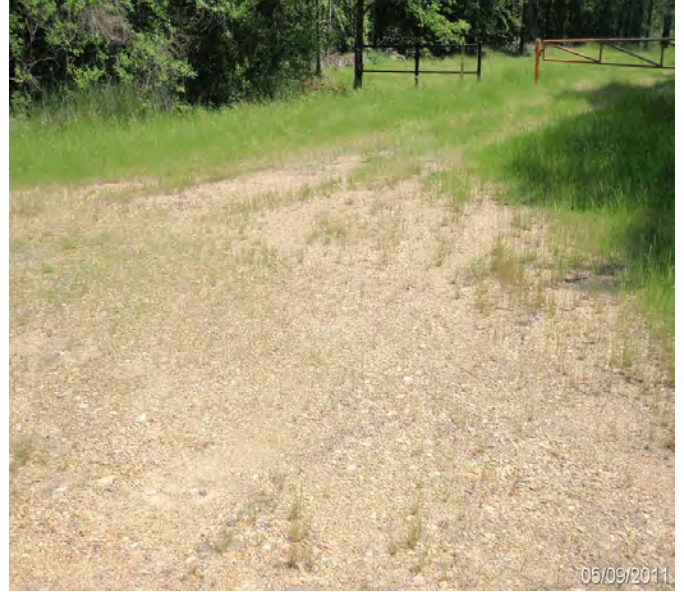
916: Tram Road ATV Parking

Asset Number	Date Visited	Surface Type	Area (Sq Ft)	Condition	Cost to Improve
	05/09/2011	Gravel	2,160	Fair	500

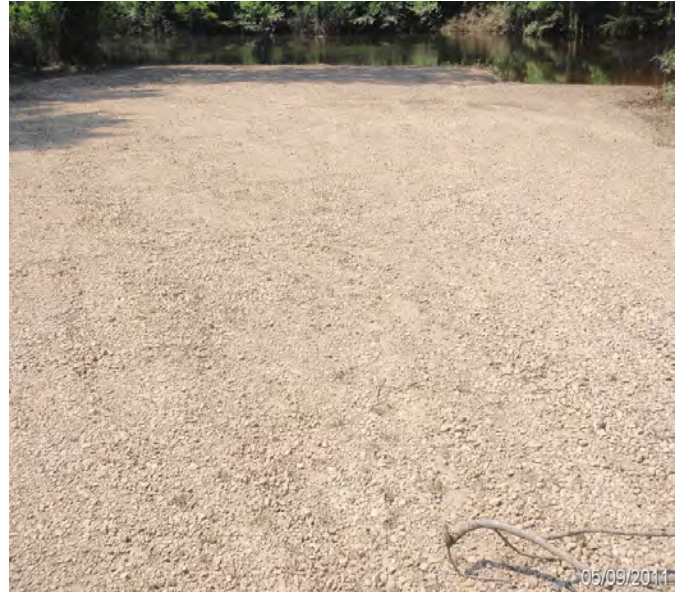
917: Jace Lake Boat Ramp Parking

Asset Number	Date Visited	Surface Type	Area (Sq Ft)	Condition	Cost to Improve
	05/09/2011	Gravel	6,758	Good	900

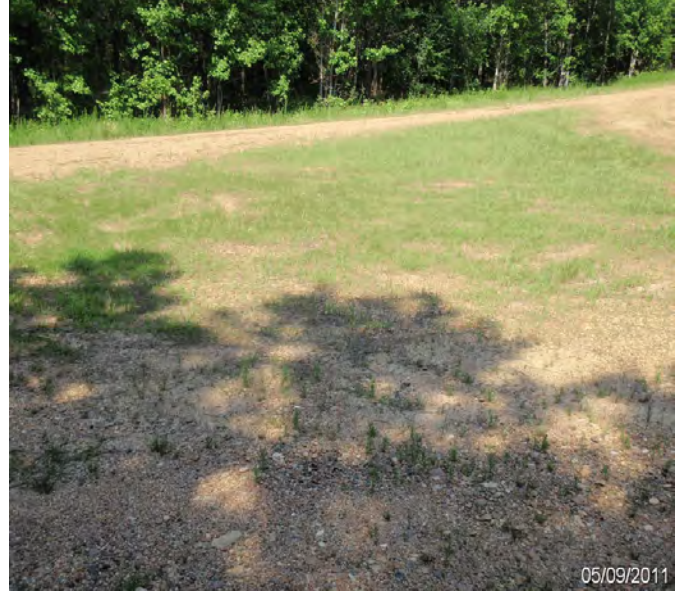
918: Pit Road ATV Access Parking

Asset Number	Date Visited	Surface Type	Area (Sq Ft)	Condition	Cost to Improve
	05/09/2011	Gravel	6,347	Fair	1,500

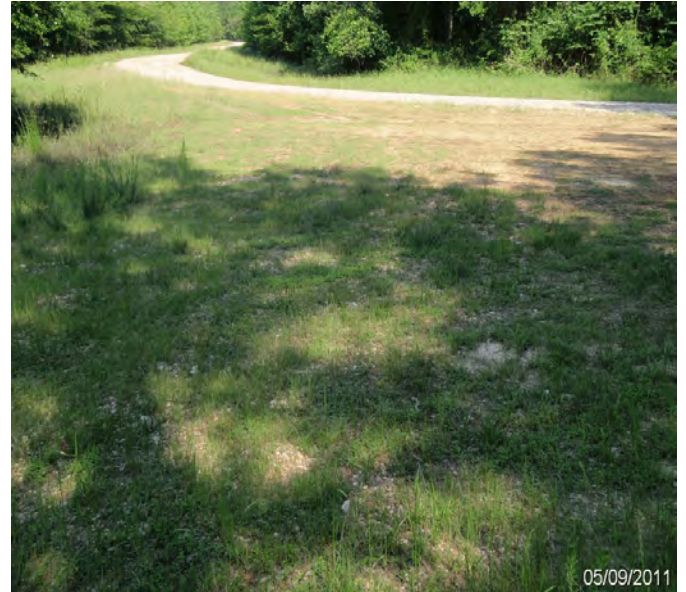
919: Dinkey Dump Parking

Asset Number	Date Visited	Surface Type	Area (Sq Ft)	Condition	Cost to Improve
	05/09/2011	Gravel	3,053	Fair	700

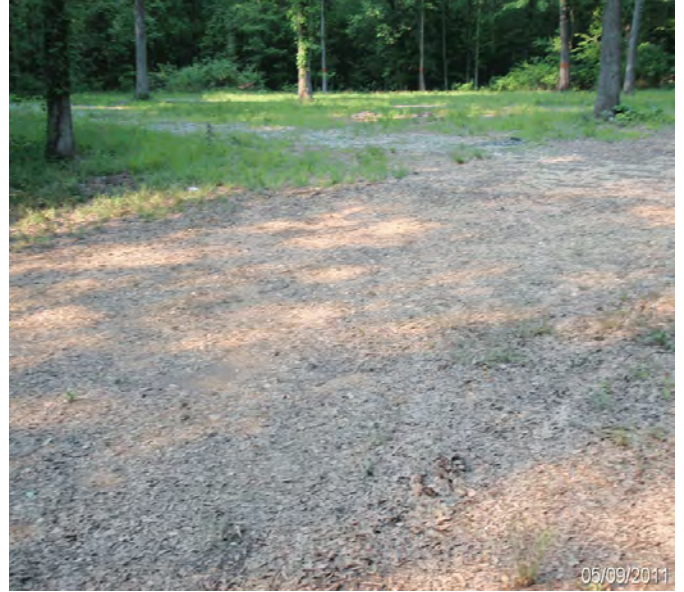
921: Crane Lake Parking

Asset Number	Date Visited	Surface Type	Area (Sq Ft)	Condition	Cost to Improve
	05/09/2011	Gravel	2,328	Poor	2,300

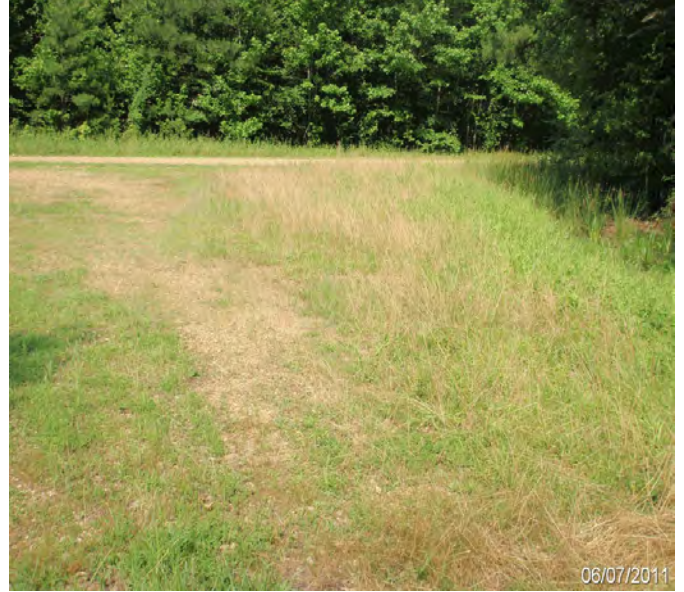
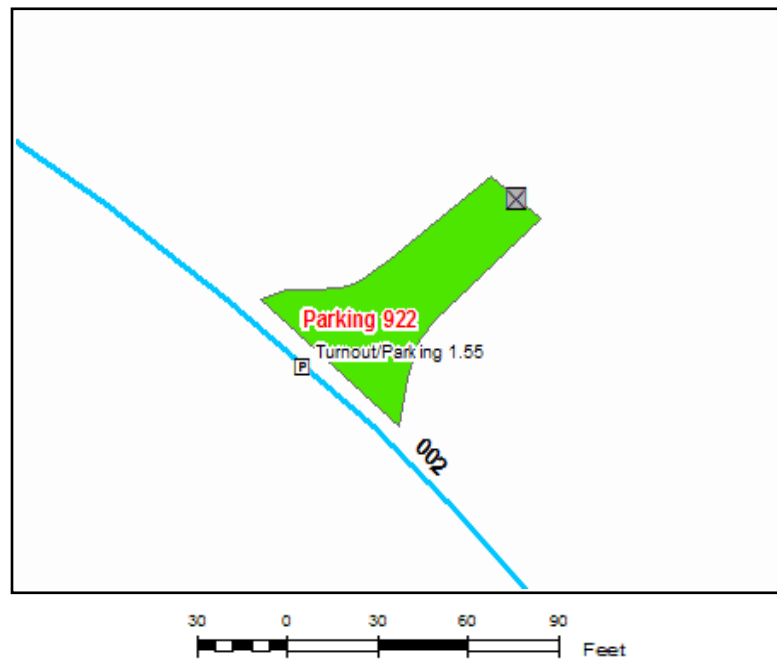
922: Bee Gum Road ATV Parking 1

Asset Number	Date Visited	Surface Type	Area (Sq Ft)	Condition	Cost to Improve
	06/07/2011	Gravel	2,998	Good	400

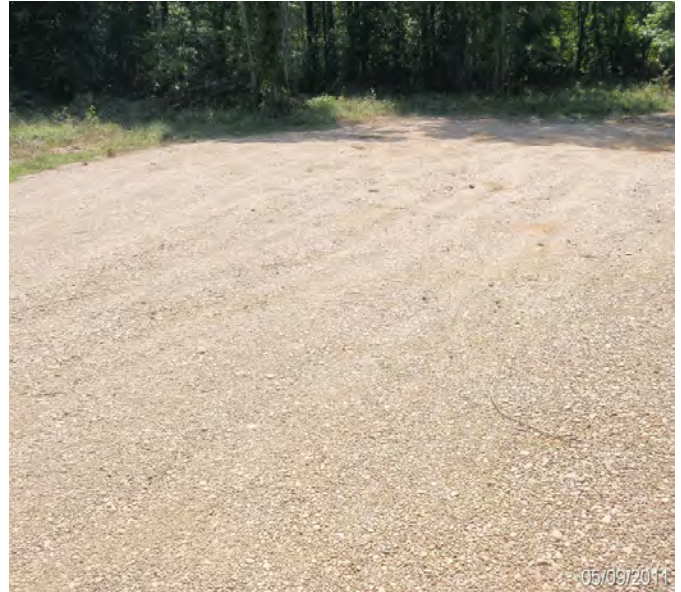
923: Litchford Lake Parking

Asset Number	Date Visited	Surface Type	Area (Sq Ft)	Condition	Cost to Improve
	05/09/2011	Gravel	5,410	Good	700

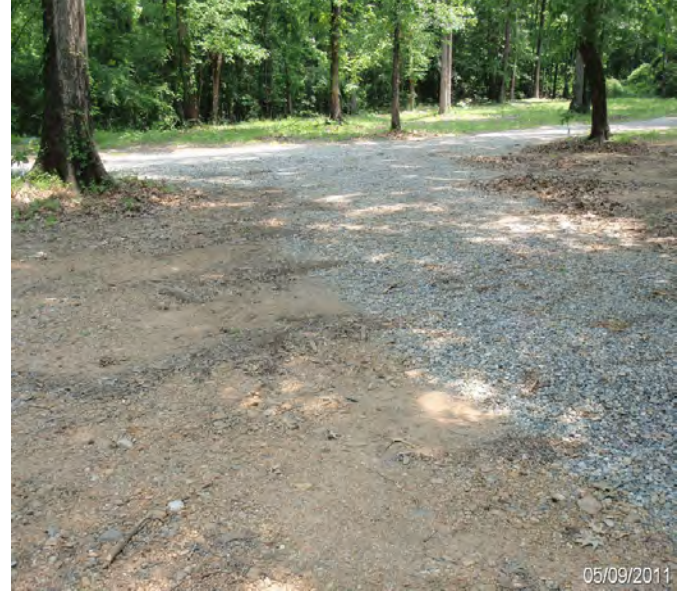
924: River Road Campground Parking

Asset Number	Date Visited	Surface Type	Area (Sq Ft)	Condition	Cost to Improve
	05/09/2011	Gravel	8,138	Fair	1,900

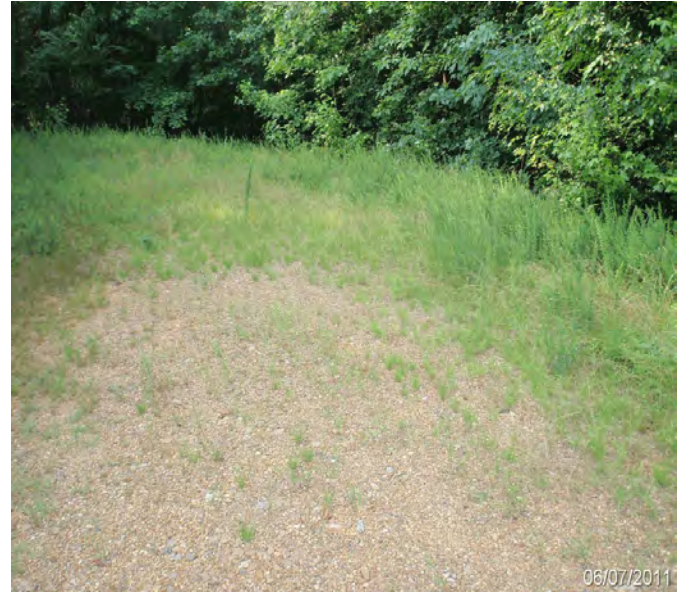
925: CC Spur Road Parking

Asset Number	Date Visited	Surface Type	Area (Sq Ft)	Condition	Cost to Improve
	06/07/2011	Gravel	2,490	Fair	600

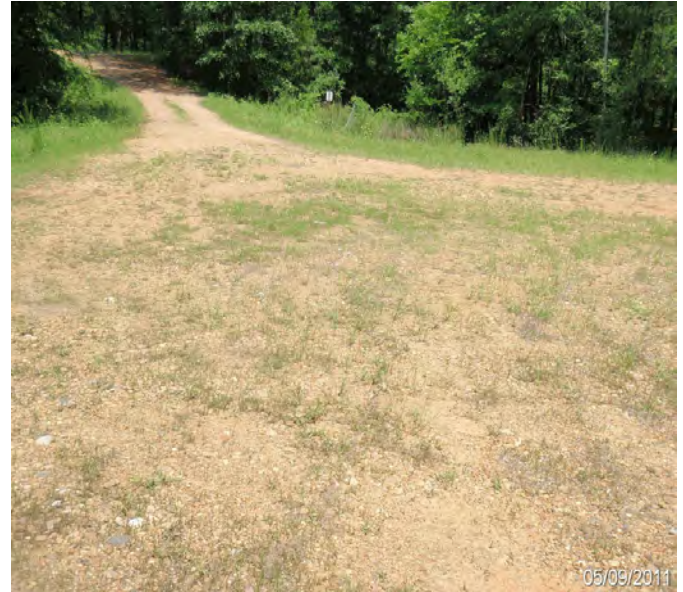
926: Old Hwy 71 Trailhead Parking

Asset Number	Date Visited	Surface Type	Area (Sq Ft)	Condition	Cost to Improve
10018166	05/09/2011	Gravel	5,482	Fair	1,300

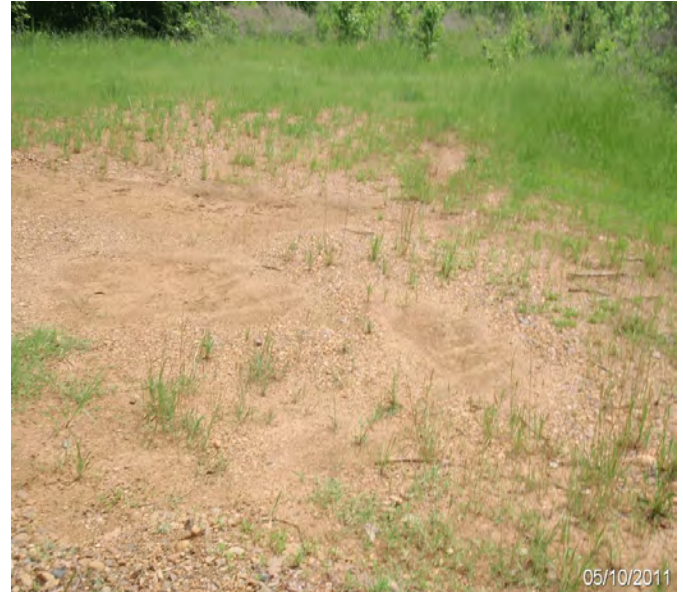
928: Morris Ferry ATV Access Parking East

Asset Number	Date Visited	Surface Type	Area (Sq Ft)	Condition	Cost to Improve
	05/10/2011	Gravel	2,508	Poor	2,400

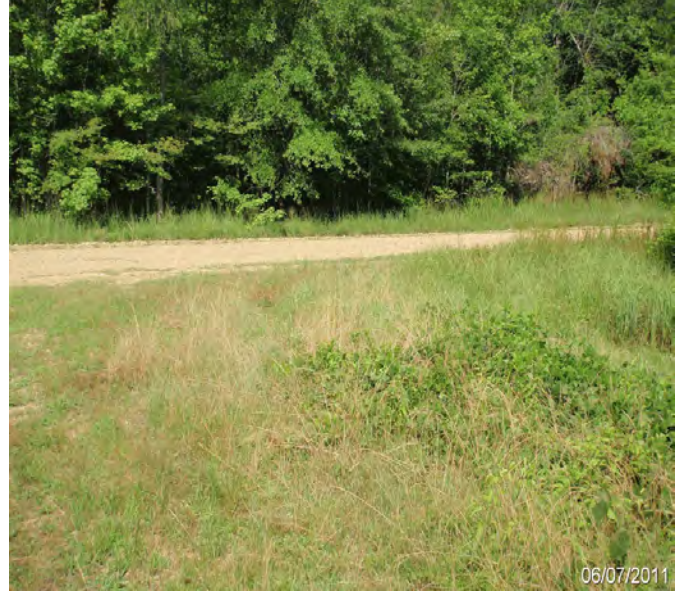
932: Bee Gum Road ATV Parking 2

Asset Number	Date Visited	Surface Type	Area (Sq Ft)	Condition	Cost to Improve
	06/07/2011	Gravel	2,027	Poor	2,000

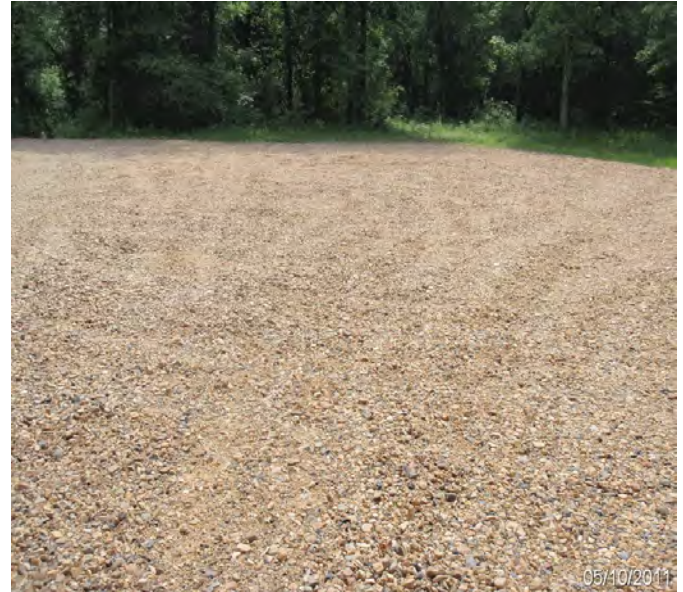
936: Beeason Road Overflow Campground Parking

Asset Number	Date Visited	Surface Type	Area (Sq Ft)	Condition	Cost to Improve
	05/10/2011	Gravel	6,847	Good	900
